RE: HIGHLAND TOWERS, INC.
2921 SOUTH OCEAN BOULEVARD
HIGHLAND BEACH, FLORIDA 33487

STRUCTURAL MILESTONE INSPECTION – PHASE ONE

PROJECT: HIGHLAND TOWERS, INC.

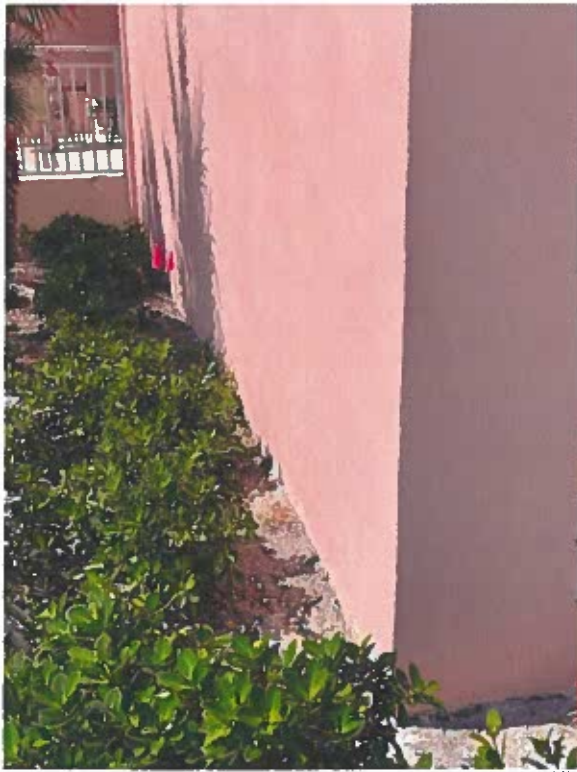
north wing - s.e. corner exterior wall without cracks

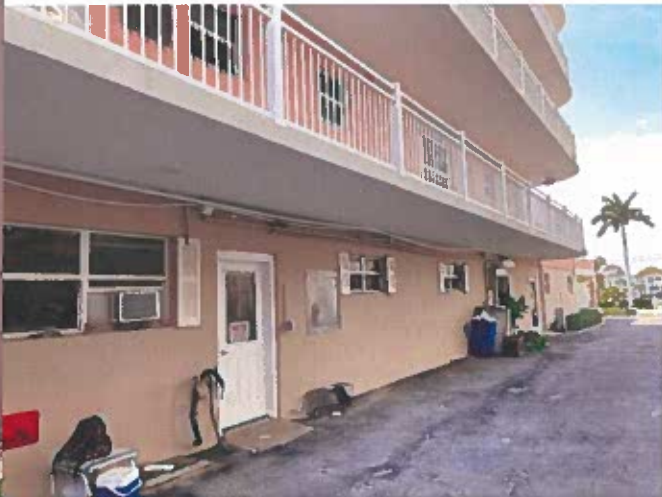
north wing – north elevation ext. ground floor wall without cracks

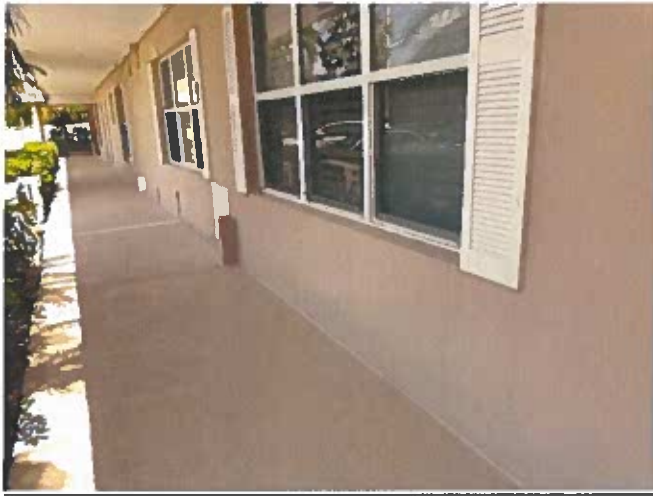
west wing – west wall elevation ext. ground floor wall without cracks

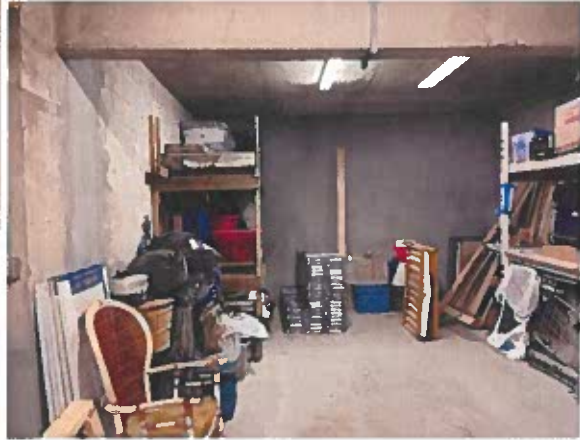
n.e. storage room – west wall, columns & floor without cracks

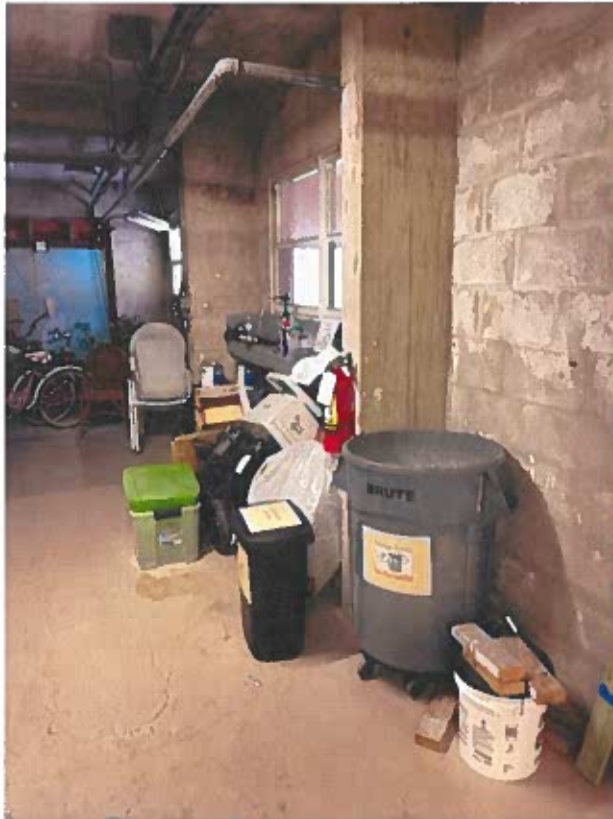
n.e. storage room – north wall, columns, ceiling, and floor without cracks

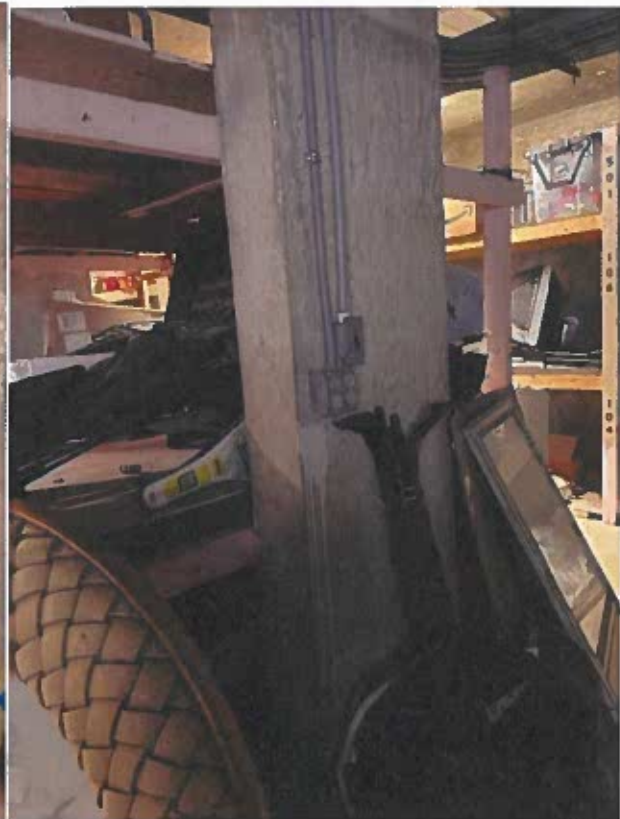
n.e. storage room – column and ceiling without cracks

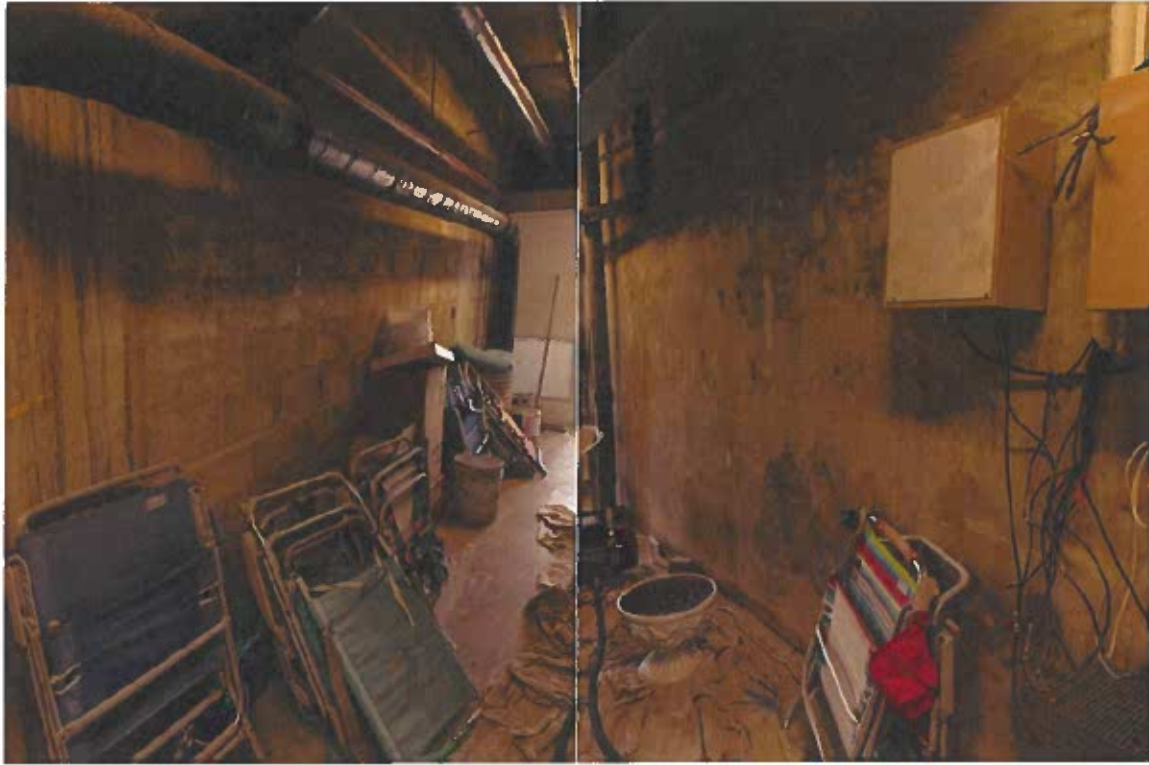
s.w.storage room – south floor, wall, ceiling, and floor without cracks s.w. storage room – north shear wall, floor & ceiling without cracks

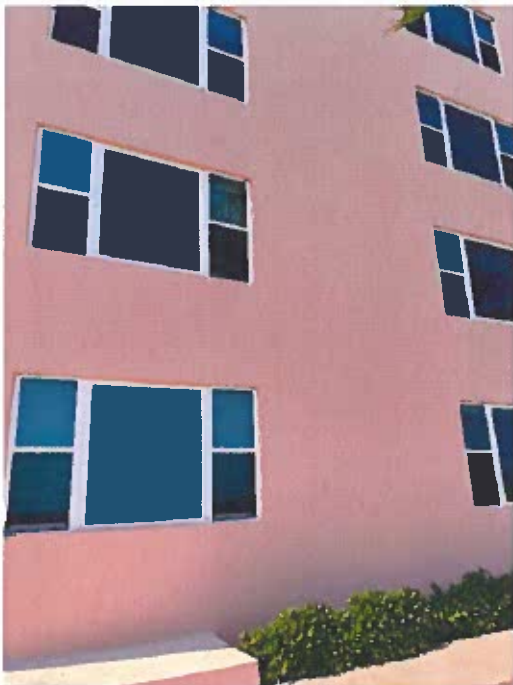
East elevation – stack 07 wall without cracks from ground up to roof

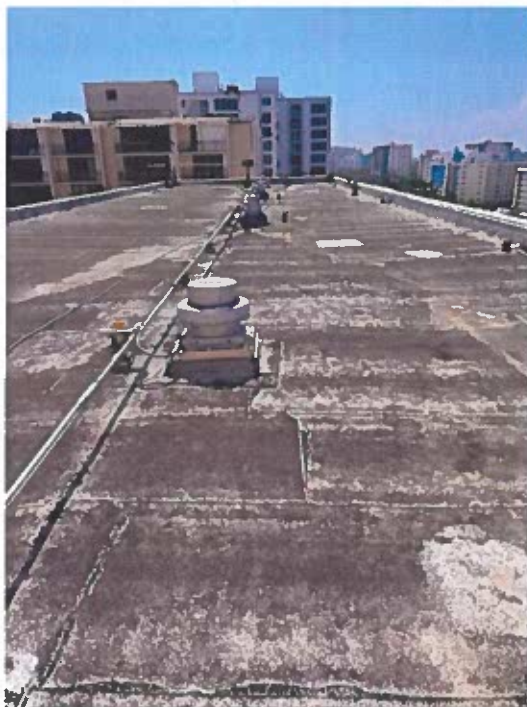
west wing – built-up roofing membrane

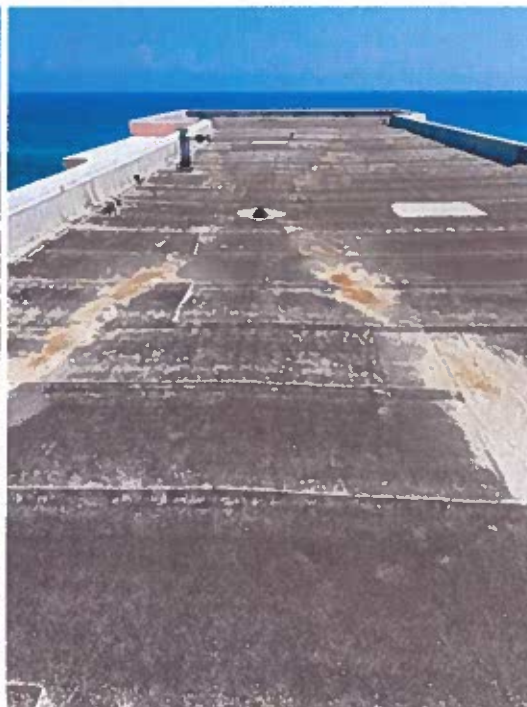
north wing – built-up roofing membrane

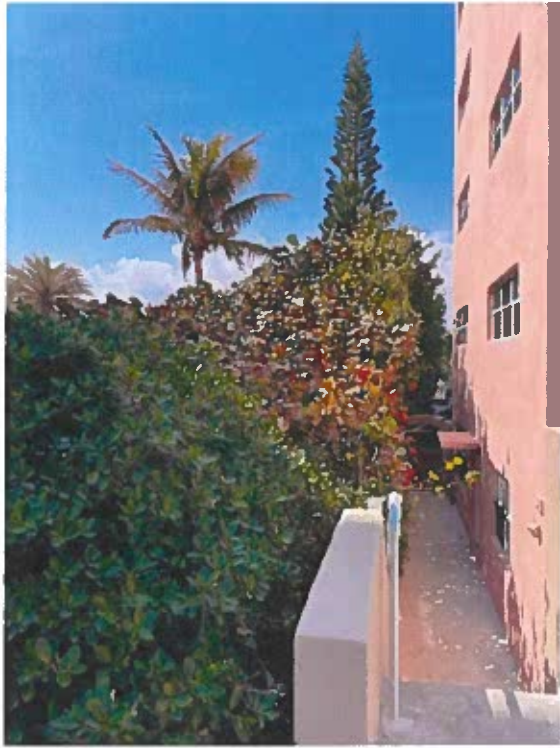
south elevation 01 stack wall without cracks and spalls

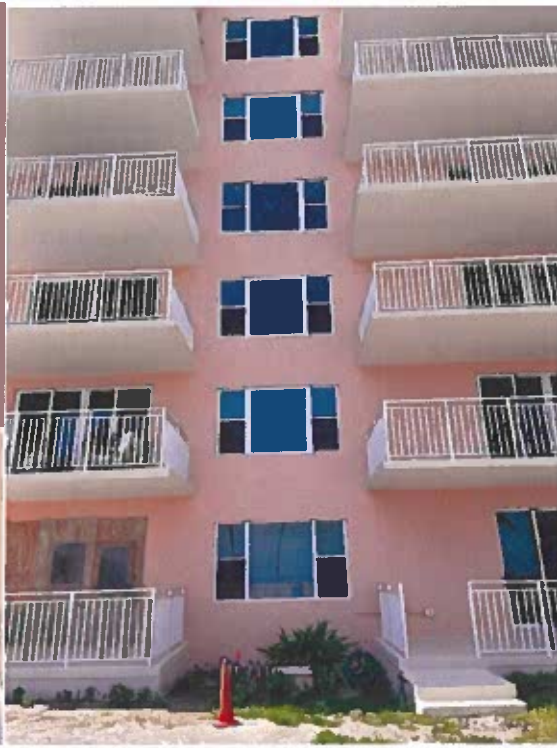
east elevation 02 stack wall without cracks and spalls

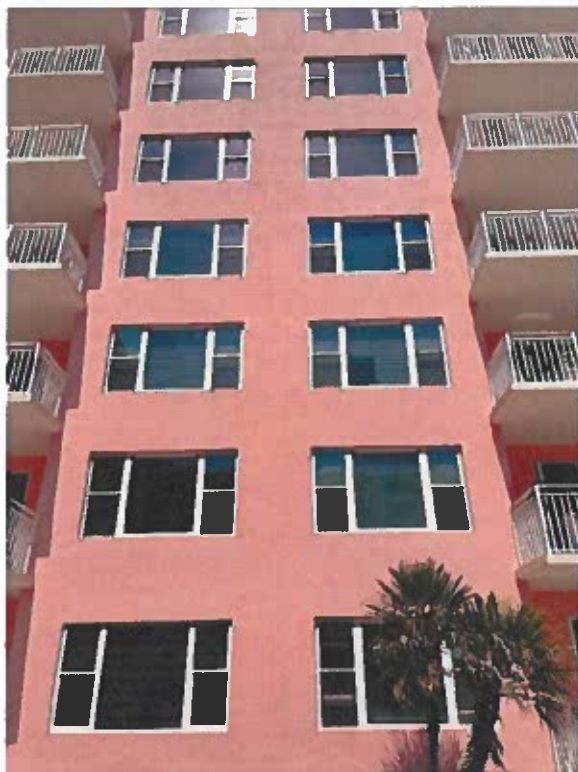
south elevation – stack 05/06 wall without cracks & spalls

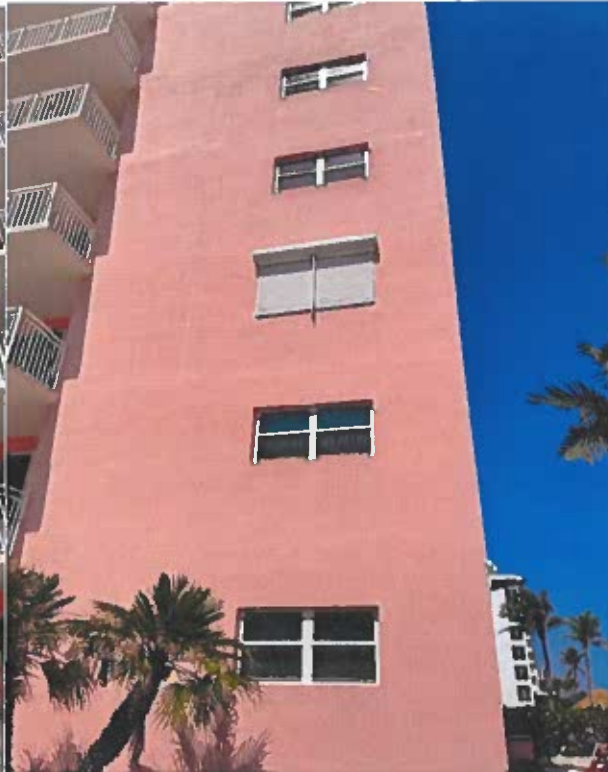
south elevation – stack 07 wall without crack and spalls

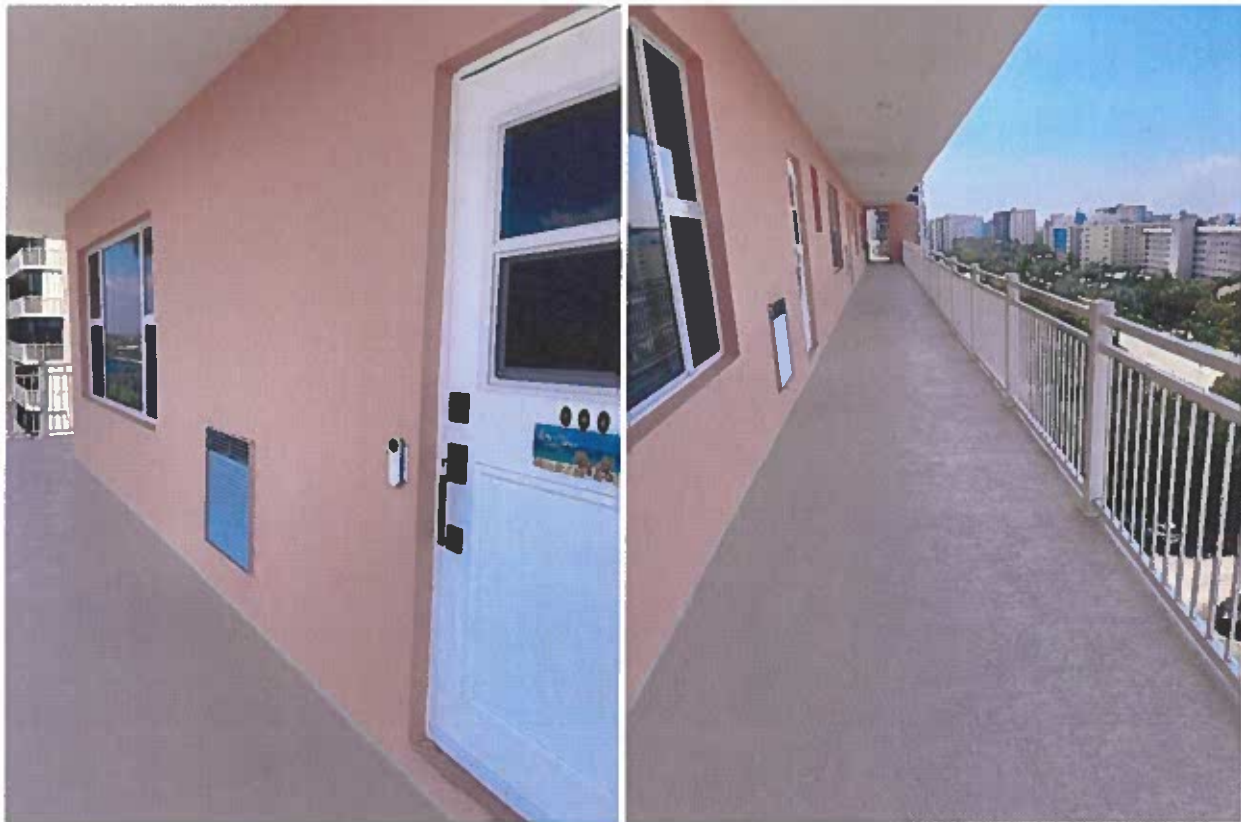
7th floor catwalk floor and ceiling without cracks & spalls

7th floor catwalk floor and ceiling without cracks and spalls

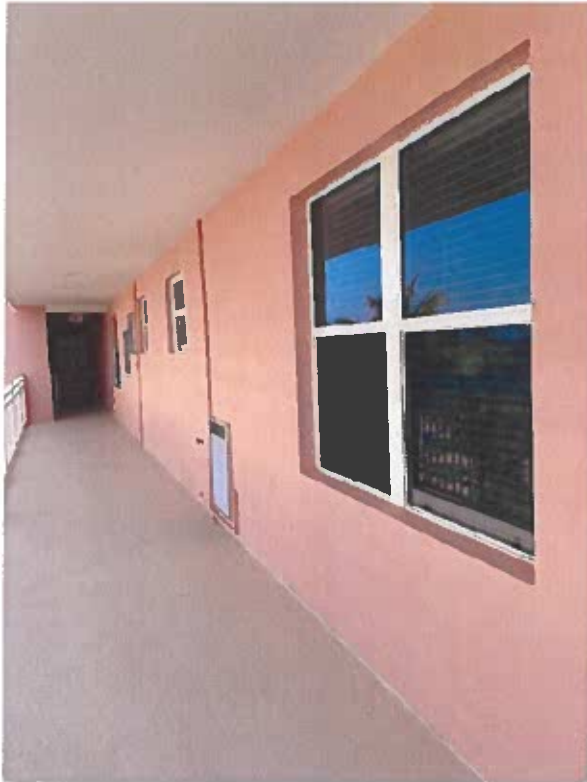
4th floor catwalk floor & ceiling without cracks and spalls

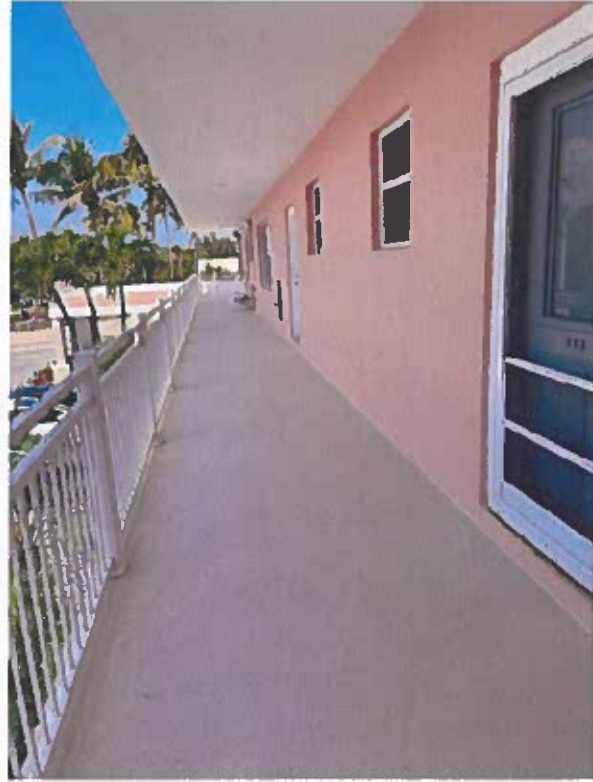
1st floor catwalk floor & ceiling without cracks and spalls

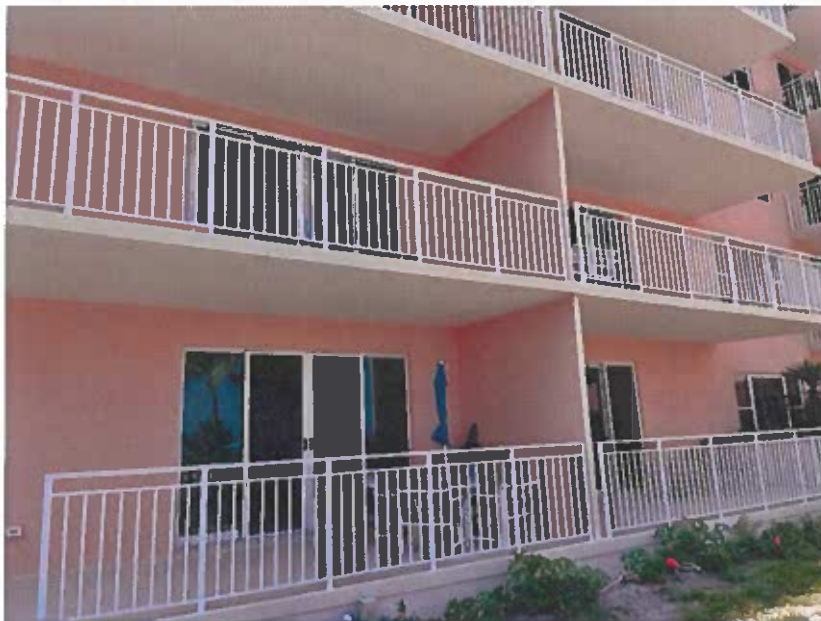
east elevation – 02/03 balcony floors, ceilings, and edges without cracks and spalls

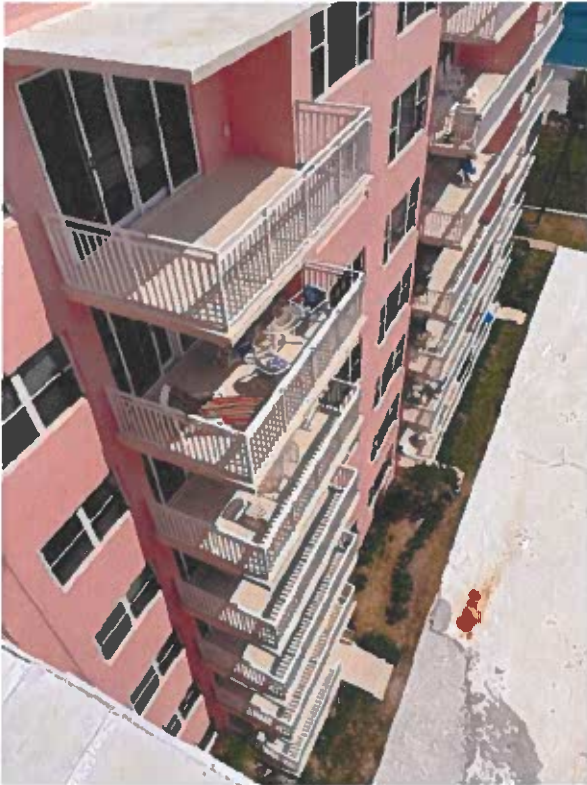
balcony stack 05 floors, walls, & ceilings without cracks & spalls

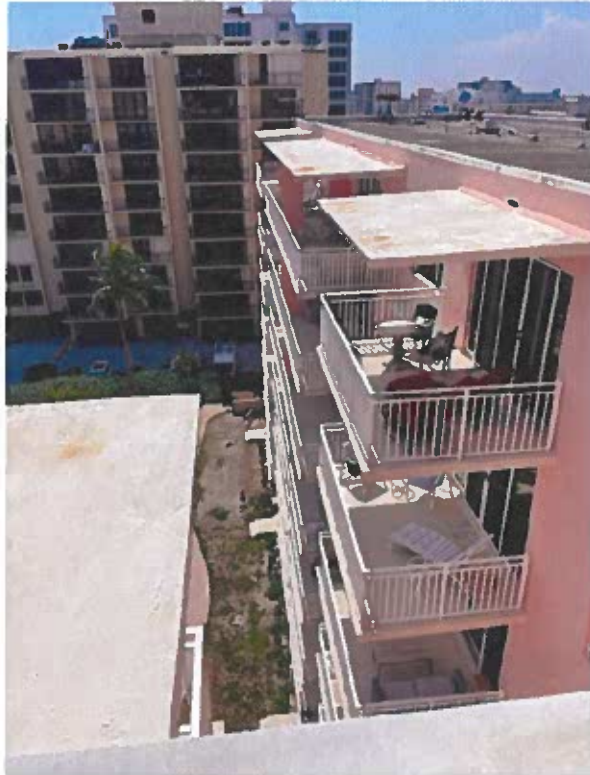
balcony stack 04, 03/02,01 floors, walls, ceiling without cracks & spalls

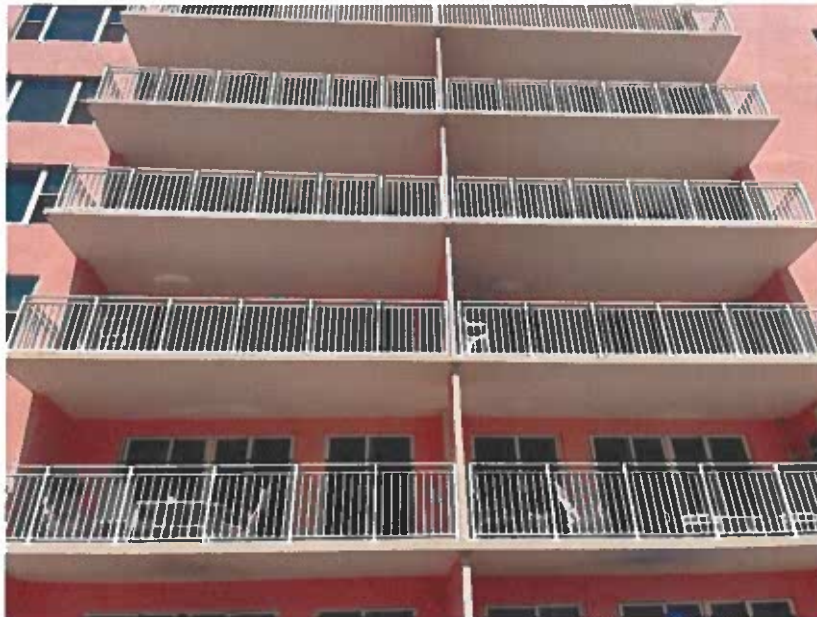
balcony stacks 06/07 floors, walls, ceilings, and edges without cracks and spalls

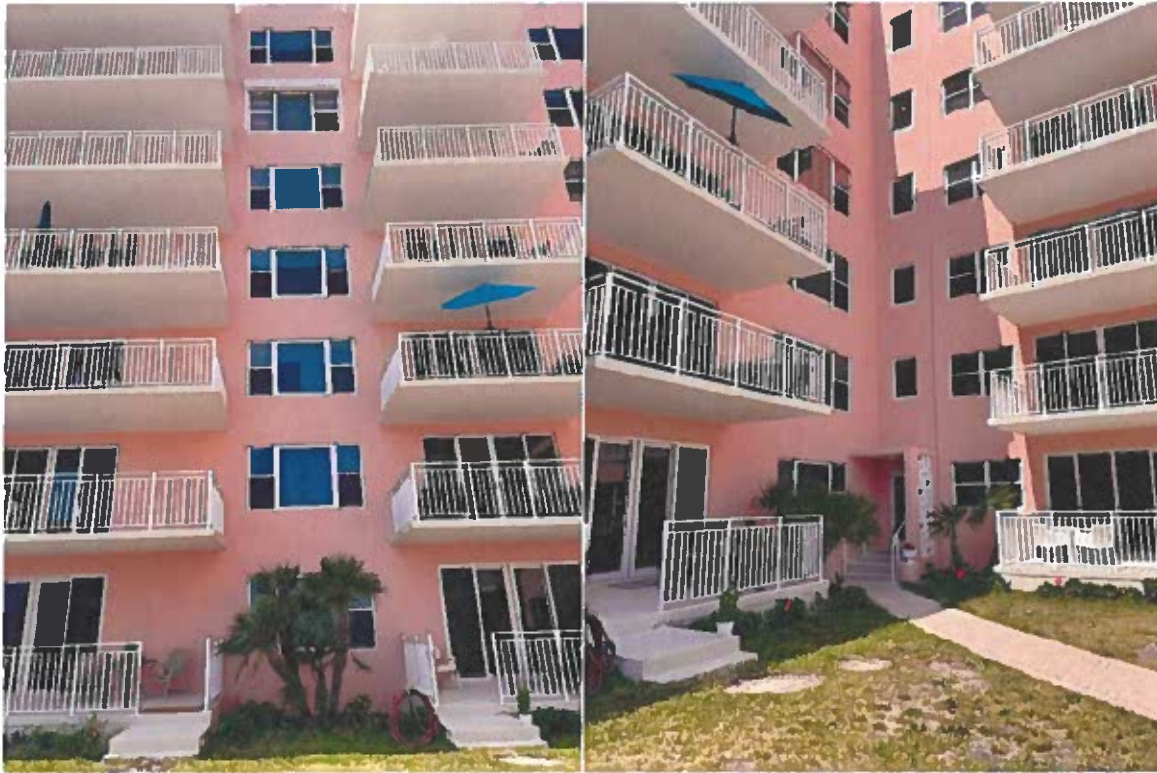
Balcony stack 02/03 floors, ceiling, edges & walls without cracks & spalls Balcony 04/05 floors, ceiling, edges & walls without cracks & spalls

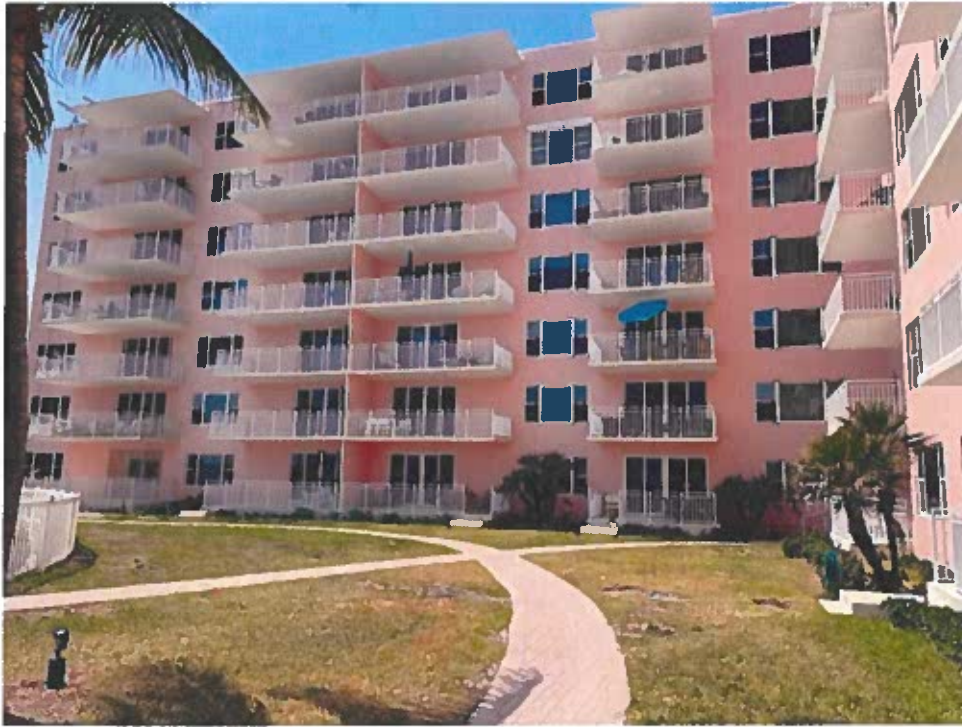
east elevation – all balconies at stacks 01 – 04 finished without balcony enclosures

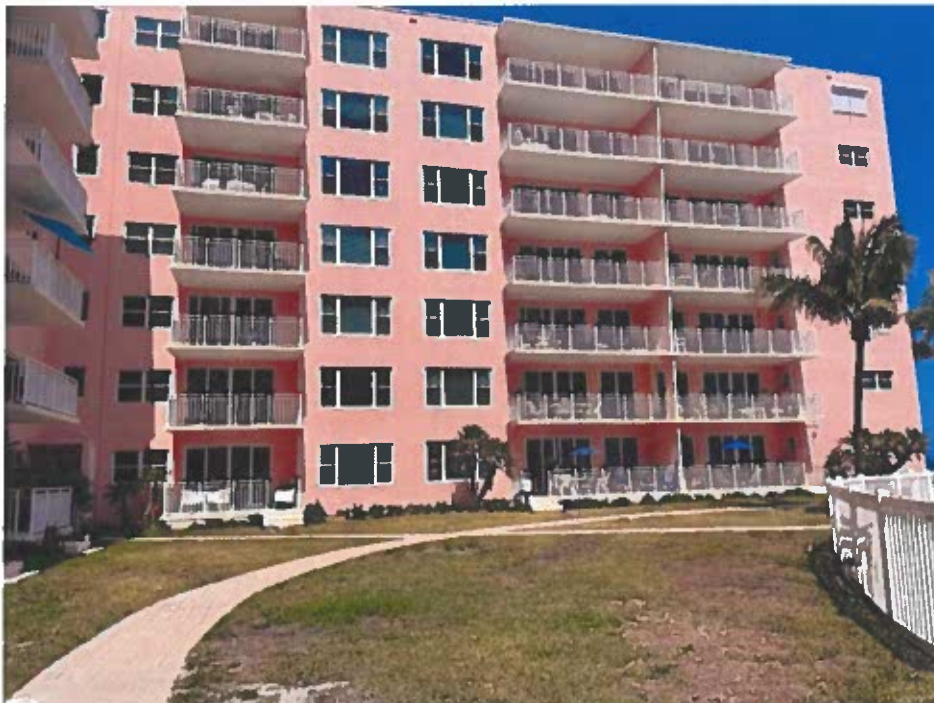
south elevation – all balconies at stacks 05 – 07 finished without balcony enclosures
